Maritime Archaeology of Ancient Cissa
Bay of Caska, Island of Pag, Croatia

ANCIENT SHIPS FROM CISSA (island of Pag, Croatia) in their cultural and historical context

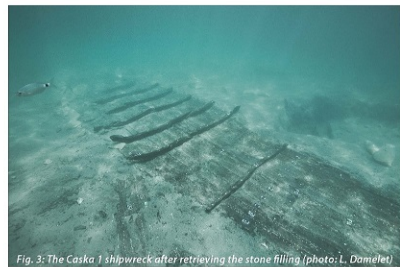
Fig. 3: The Caska 1 shipwreck after retrieving the stone filling (photo: L. Damelet)

In the zones A-B, excavated between 2009 and 2012, the first shipwreck, named Caska 1, was found. It was reused, after being filled with stones, to fortify some pier-like wooden coastal structure, composed mainly of wooden pilings and raw stone material.

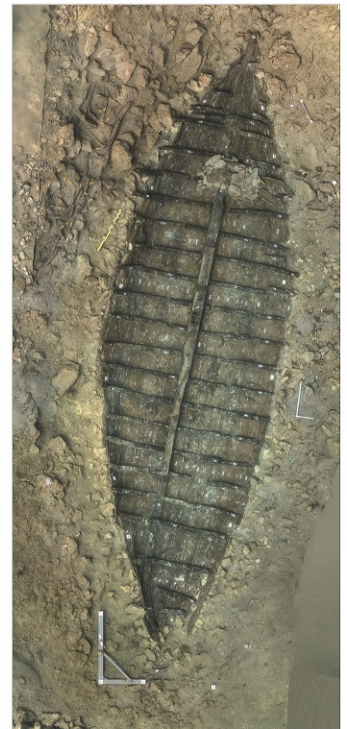
Fig. 8: Orthophoto of the Caska 2 shipwreck at the end of the 2015 excavation campaign (T. Seguin and V. Dumas)

The remains of the ship built with a typical Roman mortise-and-tenon technique are 13 m long and 4 m wide. The ship rests on the keel, inclined to starboard (east). The transverse section at the main frame is flat, with a round turn of the bilge. The preserved structure consists of the keel and ten strakes on each side (the tenth strake is a wale), flush laid and assembled by pegged tenons, twenty-four composite frames, a keelson with mast-step and some stringers. Several planks were repaired by patch tenons, and the frames present some repairs too.

Exceptionally, the hearth used for cooking was found in the forepart of the ship.

The hold of the ship was filled with loose wooden pieces, mostly planks, but also some interesting elements, such as eight thwarts, one stanchion with forked extremity, and a fragment of planking belonging to another sewn boat similar to Caska 1 (designated Caska 3).

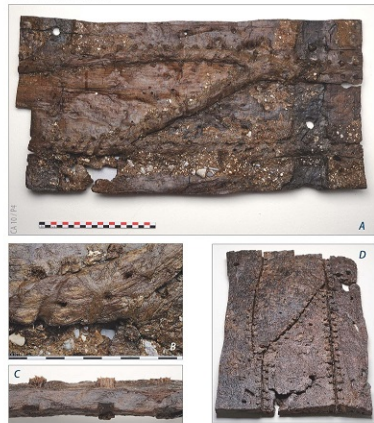
Fig. 5: A. The stitching pattern is simple (forecast seams). A braid made from 3 strands tightly held the wadding pad; B. Cross seams reinforce the stitching at the level of the oblique scarfs; C. Recesses cut on the thickness of the planks to hollow the passage of the seams; D. The grooves to house the stitching on the outer of the hull (photo: L. Damelet)

A repair was observed on the east side. Planks were all made of beech (*Fagus sylvatica* L.) and were laced to each other. The stitching pattern was similar to that observed on the shipwrecks found at Nin/Zaton and Pula. The seams were blocked by small tapered pegs, mostly made of fir (*Abies alba* Mill.). The pegs were driven from the inner side of the hull at an average space centre-to-centre of 2.4 cm. The lacing channels were perpendicularly drilled through the thickness of the planks. The outer internal edges of the planks bear the traces of small rectangular recesses for protecting the lacing cords. A wadding pad was placed at the top of the junctions between planks, inside the hull, and held tightly by the lacing cords. A thick layer of pitch completed the watertight system.
